Abstract

Charles Bridge in Prague is one of the most prominent historical structures in Europe. It was founded in 1357 by King Charles IV. The bridge interconnects two Prague districts, the Lesser Town and the Old Town, detached by the Vltava River. In the past, the bridge underwent a variety of damages, repairs and retrofits. Within the framework of the last reconstruction in 2007 - 2010, a measuring system was installed in the bridge and the temperature and moisture content at selected gauge points have been continuously monitored for a period of two years. This paper presents a non-linear coupled hygro-thermo-mechanical analysis of a current state after the last intervention. The analysis is based on Kiessl and Künzl's heat and moisture transfer model and a 3D orthotropic constitutive damage model. The main indicator of crack localization is the damage parameter. The cogency of temperature and moisture evolution is validated against experimentally obtained temperature fields.

Keywords: heat and moisture transfer, damage model, masonry arch bridge, finite element method.

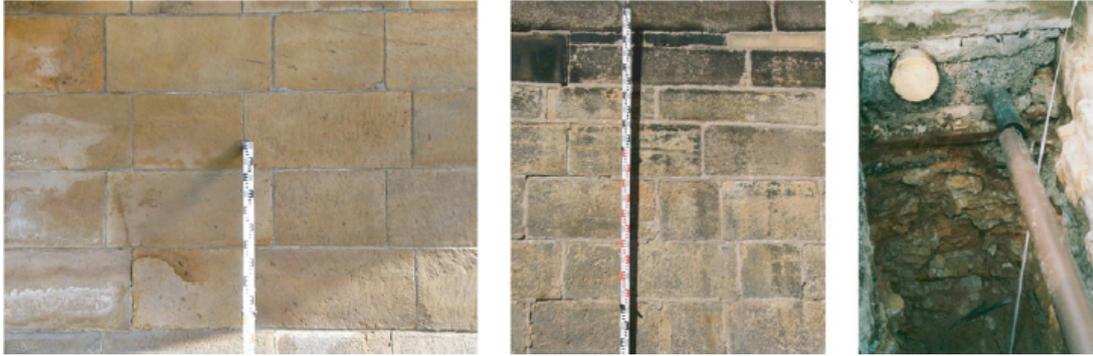
Figure 3: Periodic sandstone, non-periodic sandstone and filling masonry in the Charles bridge [5].

- Regular periodic sandstone (upper Cretaceous quartz sandstone and carboniferous arkoses) ashlar (opus quadratum) facing of vaults (Figure 3 left), bound on lime mortar from sandstone stucco and hydraulic lime [7].

- Sandstone masonry (opus quadratum) with a non-periodic arrangement of blocks used in the facing of breast walls (Figure 3 in the middle).
- Filling irregular quarry masonry (opus caementicium) consisting of arenaceous marl blocks and mortar made of sand and black hydraulic lime (Figure 3 right). Classified as structural mortared rubble masonry (MRM technique) [3] according to the heterogeneous granulometry (from 5 to 50 cm) and the coarse particles. The aggregates are macroscopically very fine-grained (aleuropelitic) sedimentary rock of light beige to ochre colour. Despite the numerous interventions, the fill masonry is considered a Gothic original, since it is preserved in 13 out of 15 pillars and in 13 arches out of 16 [3].

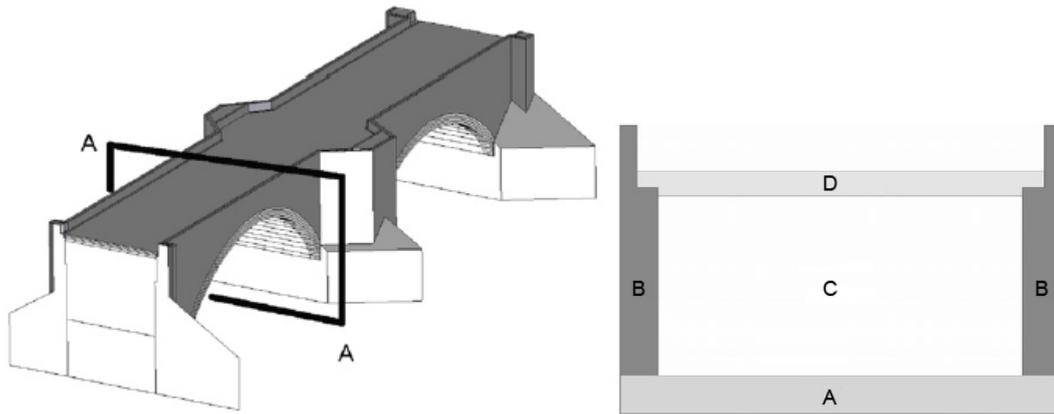
Figure 4: Schematic 3D view of Charles bridge with A-A section.

Charles bridge is constructed as a classical masonry arch bridge, where massive piers support arches - vaults. An internal infill (Figure 4 part C), laterally covered by breast walls, makes the proper level for the flooring, that includes concrete slab, gravity concrete layers, today hydroisolation and granite paving. The breast walls (Figure 4 part B) stand on the bridge arches (Figure 4 part A); in the lower part, they are 0.9 m thick, while in the upper one, the thickness is 0.4 m. They were built without expansion joints and are reinforced at the connection with piers by masonry pillars that are also pedestals for statues (Figure 4). As the breast walls, also piers and vault arches

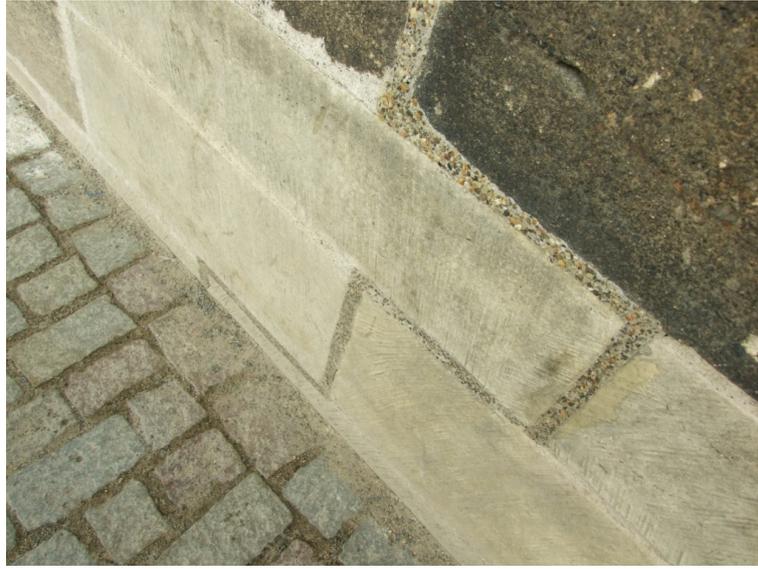
Figure 5: Dilatation joint and contrast between old and new blocks [5].

To prevent cracks evolution in the parapets and breast walls caused by temperature changes, dilatation joints have been made in the stone railing masonry in correspondence with vault/pier intersection, and usually in every approx. 4 m. They are filled with a plastic mortar mixed with stone fragments (Figure 5). It was proven the parapets, as a part of the bridge, are the most affected by the up/down movements of the vault related to summer/winter changes and by the non-uniform temperature profile of the bridge body.

and due to the vertical movements of the vaults (upwards in summer and downwards in winter). It is considered that, on the long period, the mechanism will bring to the ultimate damage the horizontal joints and consequently the repair of the parapet will be needed again. To reduce this effect, the above mentioned vertical joints filled with plastic deformable mortar have been added during the last repair (Figure 5).

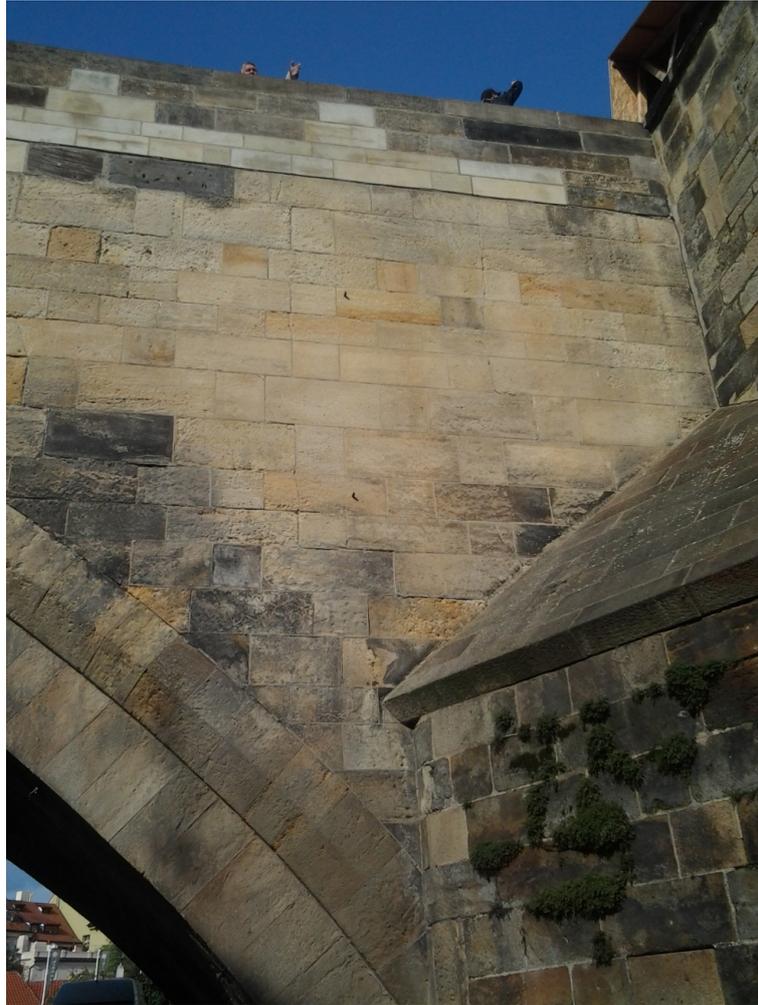
Figure 6: Visible vertical cracks in the southern breast wall of arch No. XI near pillar No. 10.

As for mechanical degradation, there are visible cracks (thickness of millimetres) in vaults, breast walls and parapets. In the vaults the cracks are aligned and located approximately 1 m from the external face of the breast wall (Figure 6). They are present also in buttresses, near the pedestals for statues and in the corners between buttress and breast wall. Many minor cracks are present also in the monument but they do not represent a menace for the structural stability.

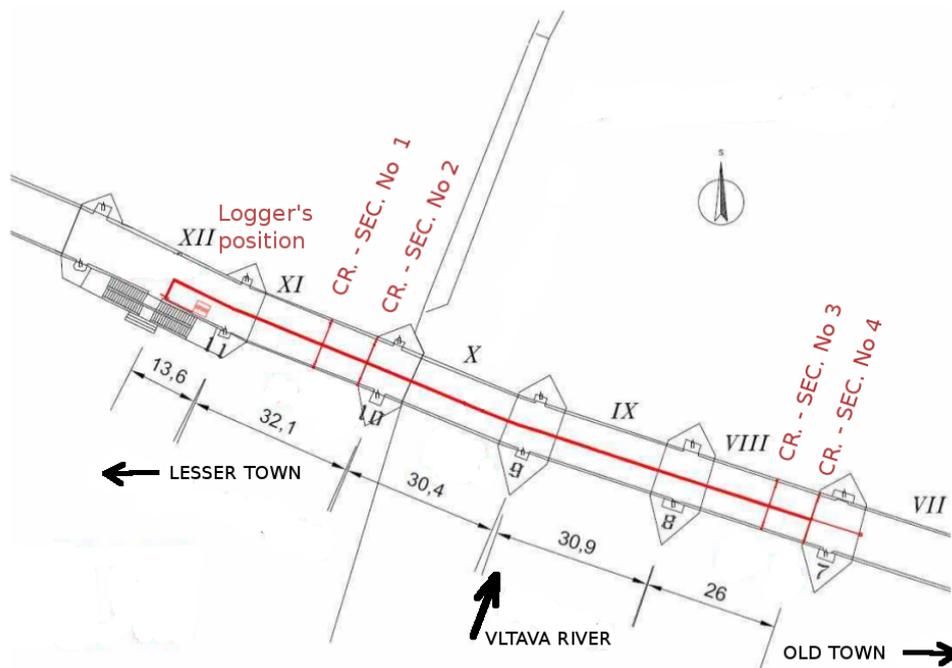
Figure 7: Layout of cross-sections selected for sensors instalment.

During the last intervention a measuring system was installed to monitor and record the temperature and moisture content. The continuous monitoring of temperature and moisture fields requires that a sufficiently dense network of reliable sensors be provided. To this end, four cross-sections of the bridge were selected and are plotted, together with the logger's position, in Figure 7 for illustration.

The control system has been allocated under the twelfth vault on the Lesser Town's side of the bridge. Cross-sections 1 and 2 situated in arch XI are 36 m and 34 m away from the logger's position, respectively. The distance of cross-sections 3 and 4 (arch VIII) from the logger is 128 m and 137 m, respectively. Several gauge points are located in the selected cross-sections 1 through 4 (C.S. 1 - 11pts., C.S. 2 - 13 pts., C.S. 3 - 11 pts., C.S. 4 - 15 pts.). Each measuring point has been fitted with three temperature sensors and with one moisture sensor. To cope with demanding simulations just one segment of the bridge, one half of arch VIII, was examined in computer experiments. The corresponding set-up in cross-sections 3 and 4 is displayed

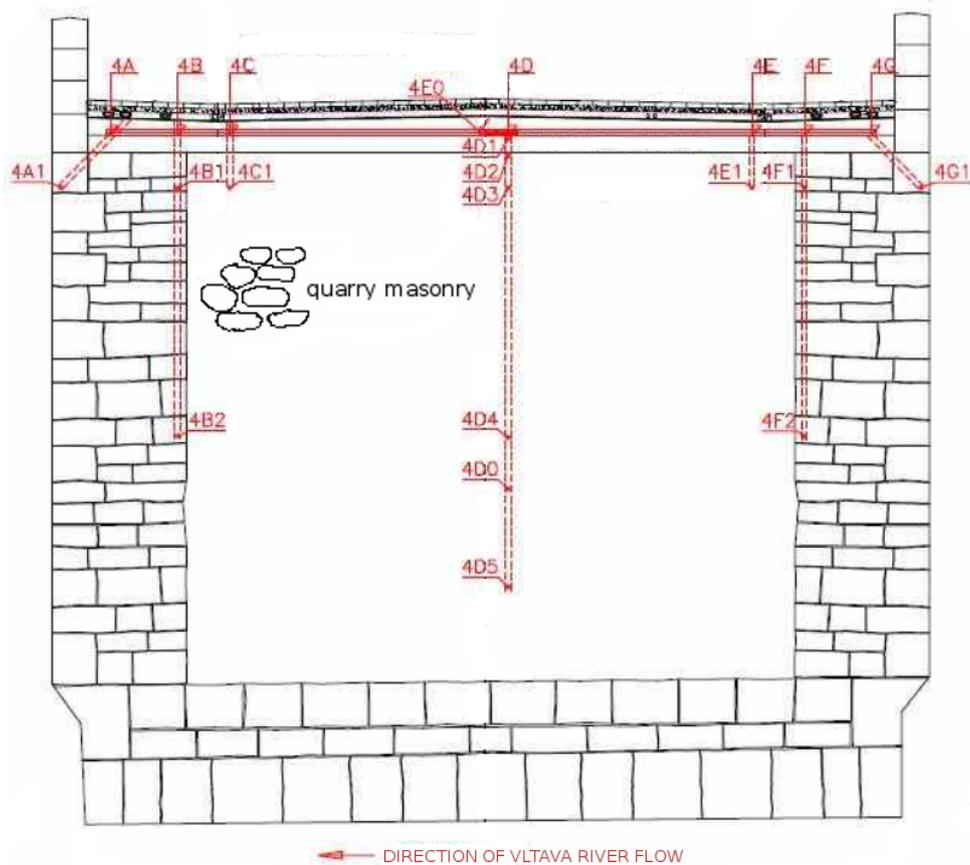
Figure 9: Cross-section 4 - gauge points (15 points, i.e. 45 temperature sensors and 15 moisture sensors).

in Figures 9 and 8.

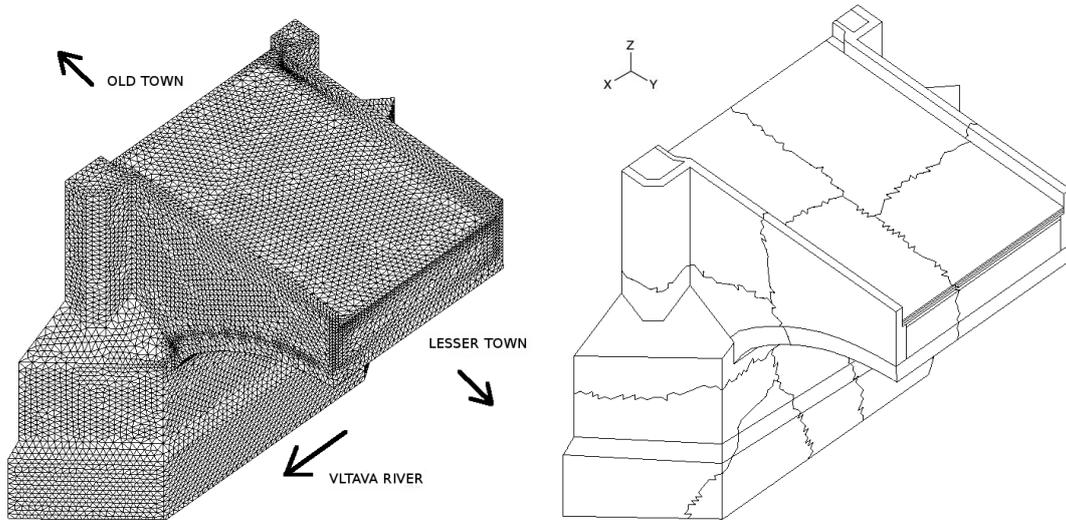
Figure 10: 3D finite element mesh model of one half of the arch III (left) and its domain decomposition (right).

The numerical model simulates the coupled heat and moisture transfer and mechanical response of one half of arch III in the course of two years, 2011 - 2012. The finite element mesh was created using tetrahedron elements with linear approximation functions. It has 73749 nodes and 387773 elements (Figure 10).

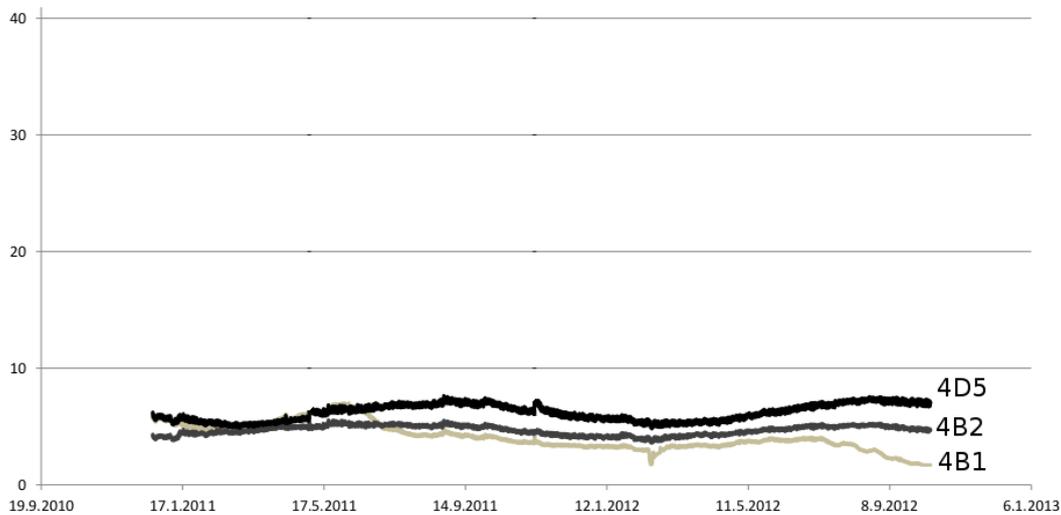
Figure 11: Measurement of the percentage increase of moisture content at gauge points 4D5, 4B2, 4B1 [%].

Taking this fact into consideration, the additional fully coupled heat and moisture transfer approach was carried out in a shorter period to assess a three-dimensional distribution of the moisture field which was then considered to remain stationary, as the difference between the evolution of the moisture content predicted on the one hand by simulation and on the other by monitoring seems to be inessential. It was experimentally ascertained that the percentage increase of the moisture content varies from 5 to 12%, see selected curves in Figure 11. These curves confirm the assumption of nearly stationary moisture content at individual material points (it varies in space, but hardly in time). Some of the sensors are adversely affected by disturbances coming from the environment (e.g., induced voltage), see end parts of the graphs in Figure 11 (lower). In any case, the reliability of the temperature sensors is much higher in comparison to the sensors monitoring the moisture content.

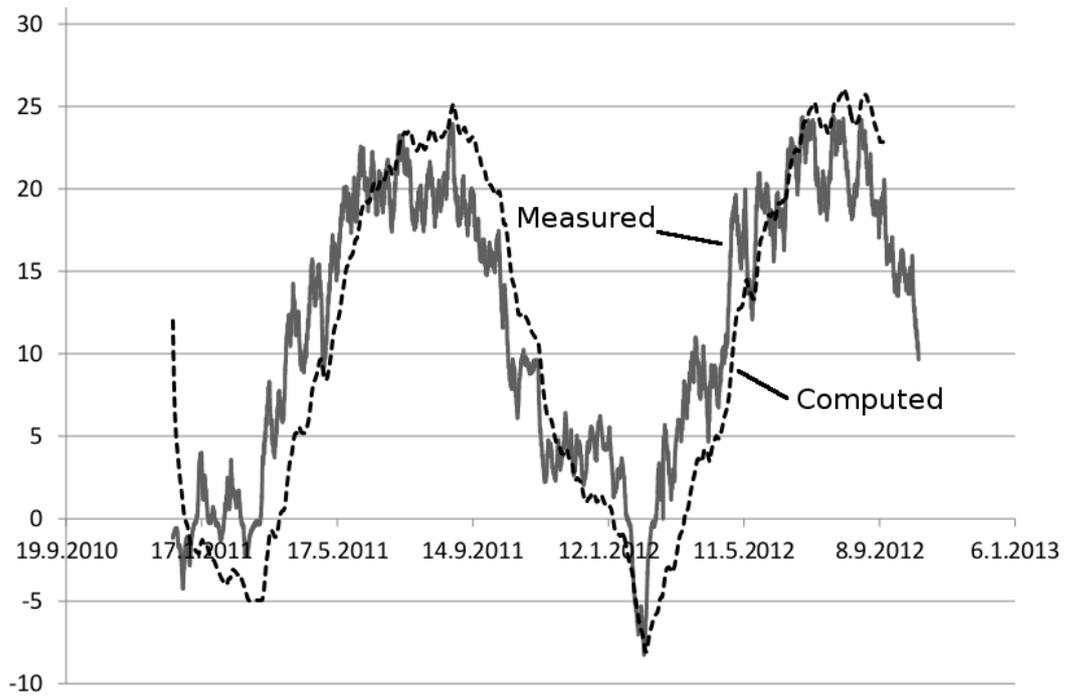
Figure 12: Distribution of temperature at gauge points 3A1 [degree centigrade]

The selected comparison of evolutions of the monitored and computed temperatures at individual gauge points are shown in Figures 12 and 13. In the early period of the calculation, a noticeable disproportion, typical of all points, is apparent between the simulated and monitored data. This is due to the incorrectly predicted distribution of the initial temperature field. Fortunately, this spurious phenomenon vanishes soon afterwards, say within 3 months at the most, and does not devalue the relevant results.

Going through these figures in detail, two findings draw attention. First, the temperature maxima in summer on the southern surface are higher by roughly 7 - 8°C compared with the northern surface. This estimate was corroborated by independent measurements at 48 points on the vertical surfaces of Charles Bridge and at 9 points located at the lower surface of arch X. To this end, the COLTCRAFT IR 650 12D temperature gauge was successfully utilized. This effect, attributed to solar radiation, is prominent namely at interior points 3A1 and 3G1, the corresponding difference of the temperature maxima interval being about 4°C. The second finding shows a certain shift between the simulated and monitored data in time, which becomes more perceptible at the points approaching the surface of the vault. As was discovered by a direct measurement of surface temperature, such an undesirable discrepancy was brought about by improperly specified boundary condition on the lower surface of arch VIII. Apparently, the exterior temperature was influenced not only by the shielding against

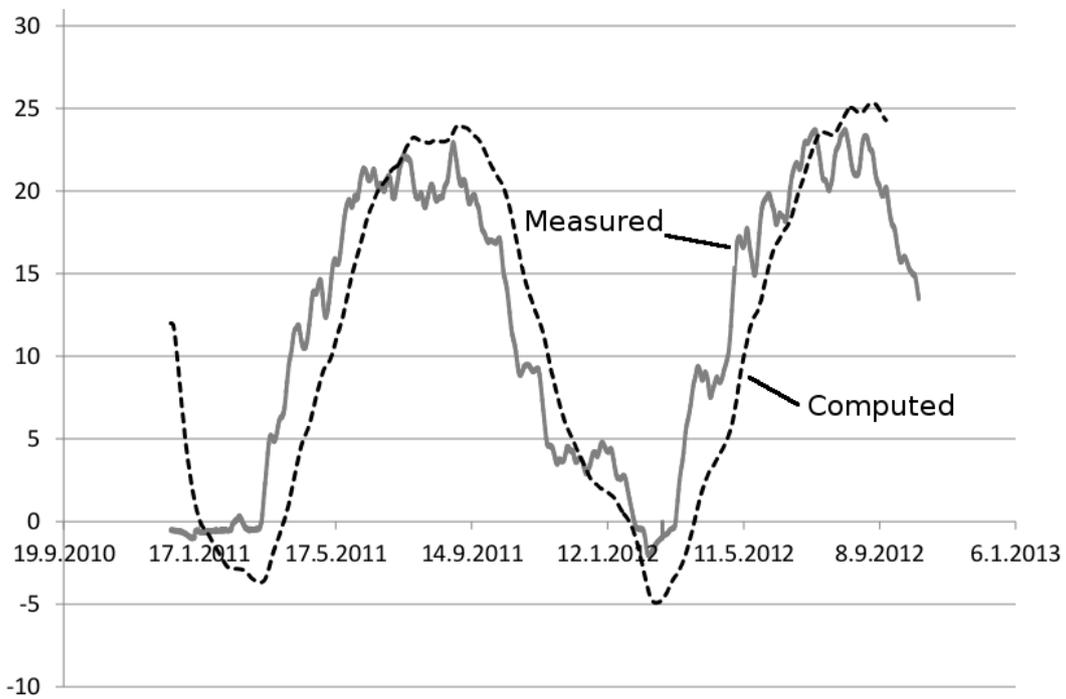
Figure 13: Distribution of temperature at gauge points 3B1 [degree centigrade]

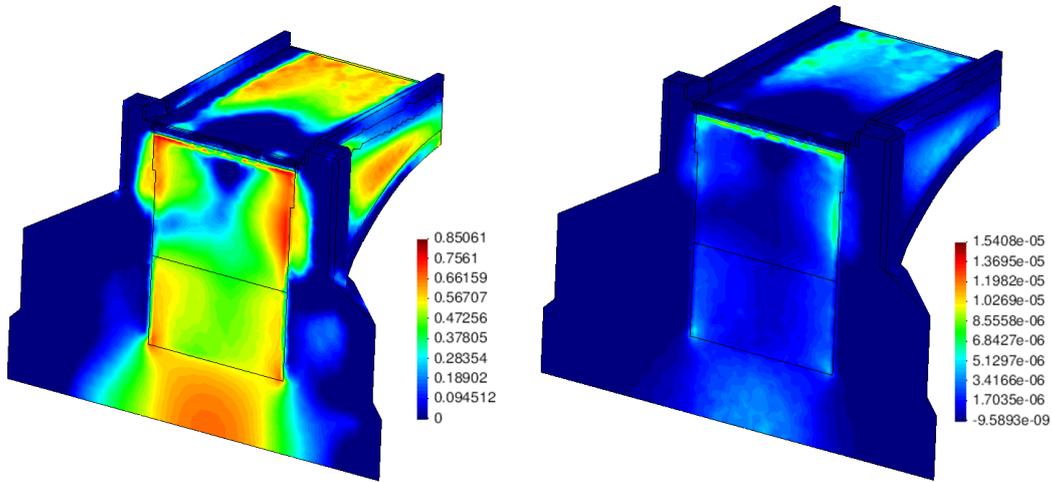
Figure 14: Spatial distribution of damage parameter in the bridge structure in summer time after one year cycle in the first principal direction (left) and corresponding width of cracks openings (right).

Figure 14 illustrates the distribution of damage parameters in the body of arch III. There are distinct damage zones in the quarry masonry filling and in the transition zone between the filling and the sandstone masonry of the breast walls. These distributions are underpinned with the spatial distributions of the temperature field in cross-sections 3 and 4 plotted in Figures 15 and 16, respectively. They show the regions where damage might be anticipated. Namely, the strong temperature gradients, accentuated in these figures with a sudden variation of colours, give rise to shear stresses in the proximity of the surfaces of the bridge and, consequently, originate massive damage in the layers localized along the interface between the quarry and sandstone masonry. The shear stresses are balanced out by tensile stresses, which then initiate the nucleation and further development of cracks in the vault and on the breast wall faces.

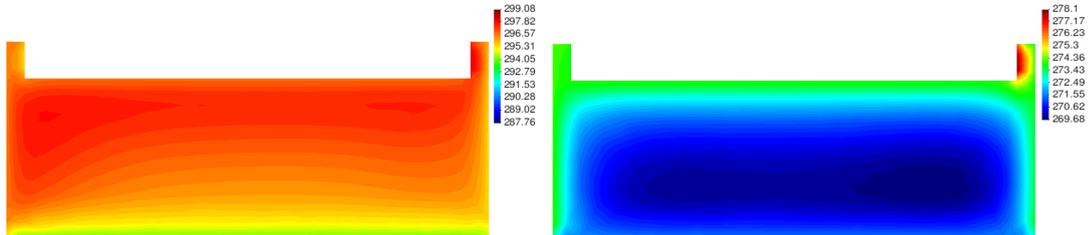
Figure 15: Spatial distribution of temperature [Kelvins] in cross-section 3 in summer (left) and in winter (right)..

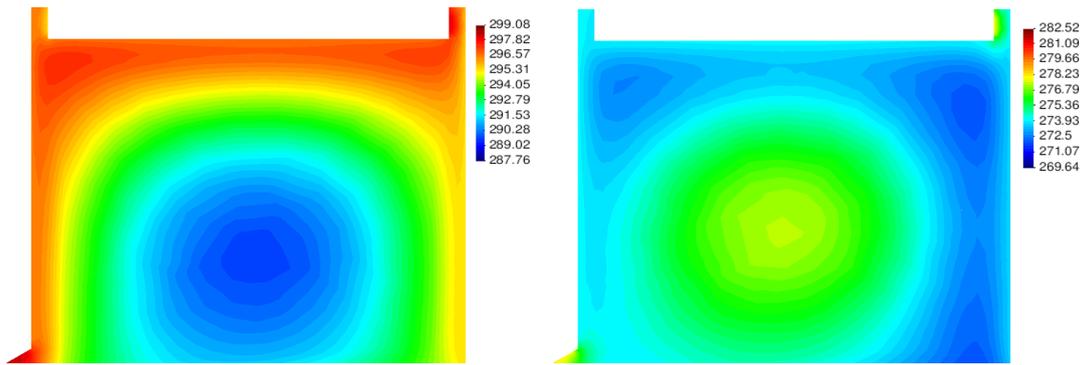
Figure 16: Spatial distribution of temperature [Kelvins] in cross-section 4 in summer (left) and in winter (right).

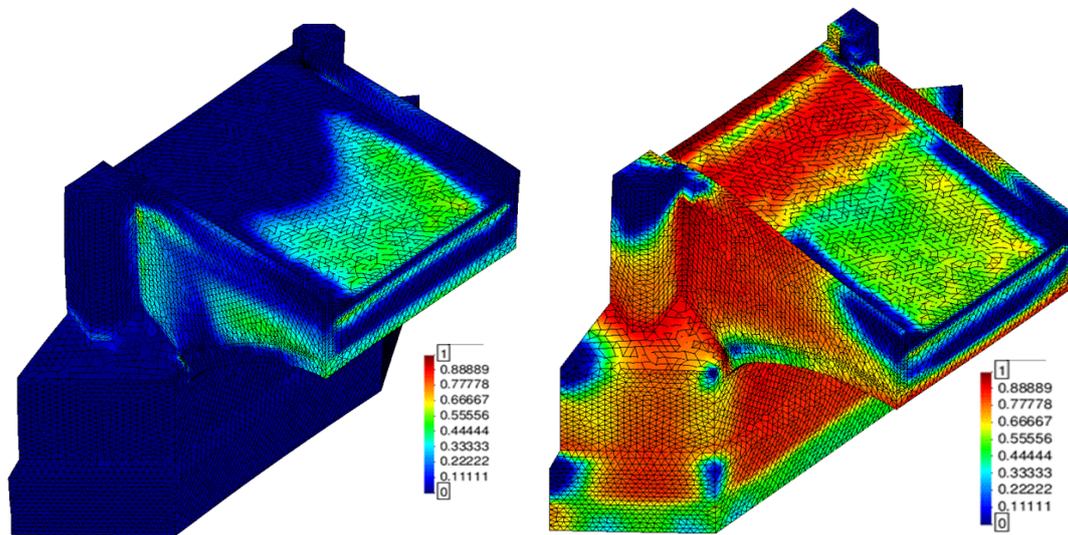
Figure 17: Deformed shape and damage parameter after two year cycles in the first principal direction in summer 2011 (left); in winter 2012 (right).

Figures 17 and 18 show damage parameters distributions and Figures 19 and 20 display the corresponding crack opening width. There are three main distinct zones of possible damage evolution in parapets and breast walls. The first zone is situated near the connection of the breast wall and pillar (Figure 19). This zone is characterized by the tensile stress due to the bridge bending. The second damage zone (Figure 20) is in the middle part of the breast wall under the bed joints of the parapet. This sort of damage is probably caused by shear stresses arising due to the differences in temperature field. The third zone is in the breast wall in the lower part of pillar (Figure 20) and is probably brought about also by the tensile and shear stresses resulting from the differences in temperature. Even the differences in temperature in the mere vertical direction and in the cross-section of the bridge arch give rise to the deformation of parapets and breast walls working against the adjacent bridge body. This effect then provokes the tensile and shear stresses evolution. The maximum crack opening width in the first principal direction reaches $1.0 \cdot 10^{-1}$ mm and the maximum crack opening width in the second principal direction is about $1.5 \cdot 10^{-2}$ mm. There is one extra visible damage zone (Figure 19) in concrete layers under the pavement, which is caused mainly by the differences in temperature in conjunction with the different thermal dilatation coefficient of materials.

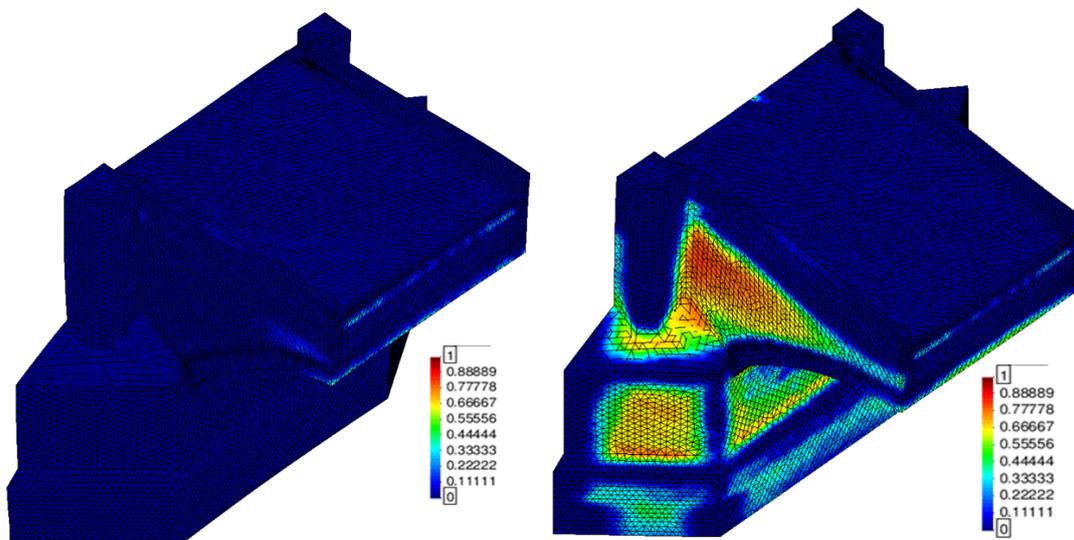
Figure 18: Deformed shape and damage parameter after two year cycles in the second principal direction in summer 2011 (left); in winter 2012 (right).

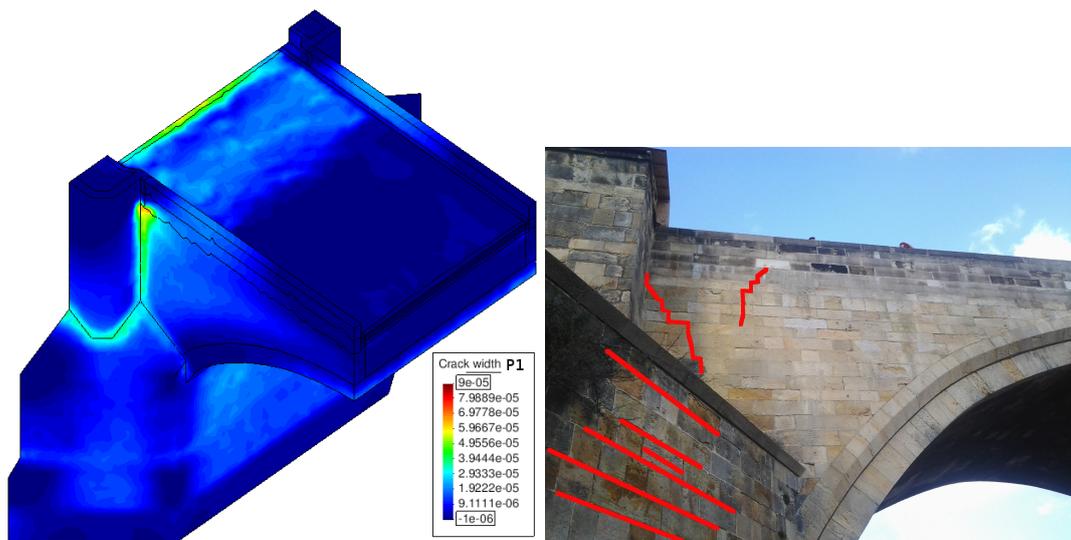
Figure 19: Distribution of the width of crack openings computed from tensile damage tensor after two year cycles in the first principal direction (left) in winter 2012; red highlighted visible cracks in breast walls (right) of arch X.

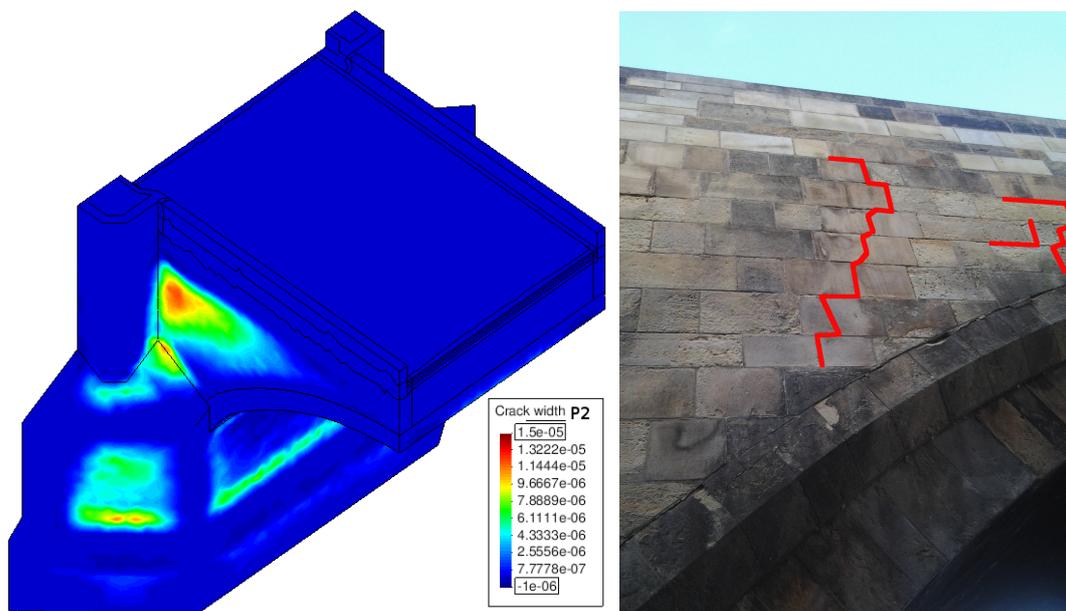
Figure 20: Distribution of the width of crack openings computed from tensile damage tensor after two year cycles in the second principal direction (left) in winter 2012; red highlighted visible cracks in breast walls (right) of arch X.
